# Field Bulletin

- Harness Keying Issue
- SC6602 ONLY

<b>Bulletin #:</b>	<b>FG00804 Rev A</b>
<b>Bulletin Date:</b>	<b>November 10, 2004</b>
<b>Subject:</b>	<b>Interface Harness Key Plug</b>
<b>Affected Model(s):</b>	<b>SC6602 <u>Only</u></b>
<b>Updated Config. Code #:</b>	<b>N/A</b>

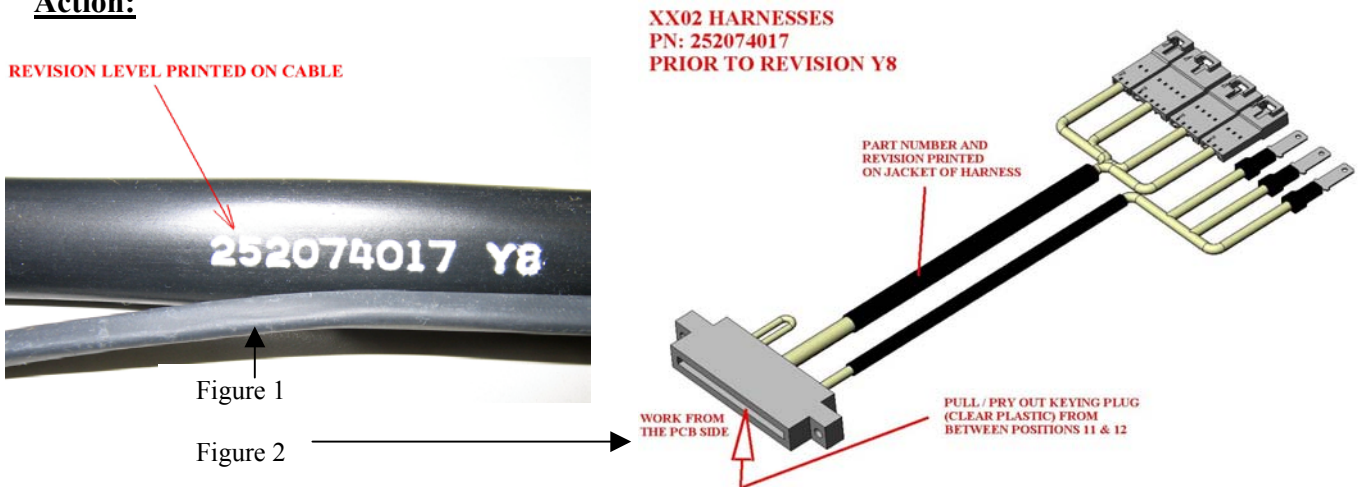
The Y8 revision Interface harness for the SC6602 that has the keying plug installed will not mate properly when used with a newer SC6602 interface card. Newer interface cards have the key slot removed.

After identifying a harness in the field that has the keying plug, a rework procedure needs to be performed. The rework can be performed with the interface harness still mounted to the chassis, or with it removed from the chassis mounting points.
