Field Bulletin

- STS 3.0
- Upgrading PPM Firmware

Bulletin #:	FG00406
Bulletin Date:	March 10, 2006
Subject:	Upgrading PPM Firmware
Affected Model(s):	STS PPM's

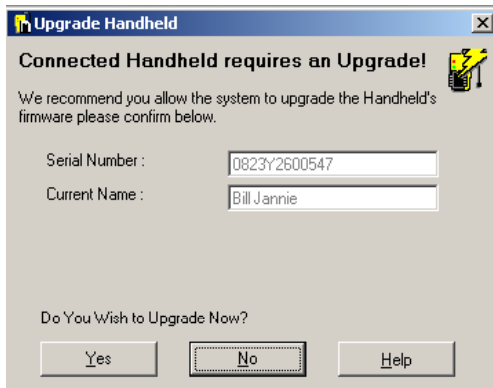
Fig.1

- When using a BPM that hasn't had its internal firmware updated (Application V1.20 or earlier, see Blue arrow fig.2), You will need to upgrade it with V1.30. You will be prompted to do so with the message below (see fig.1).

- STS V3.01 will automatically prompt you to update a PPM only if the application firmware is older than V1.30.
- After selecting the update from either of the two options described earlier, wait for the update to be complete before unplugging the PPM. **Failure to do so will cause the PPM to lock up.**
- Any questions concerning this procedure can answered by your local MEI representative or an AESI representative.

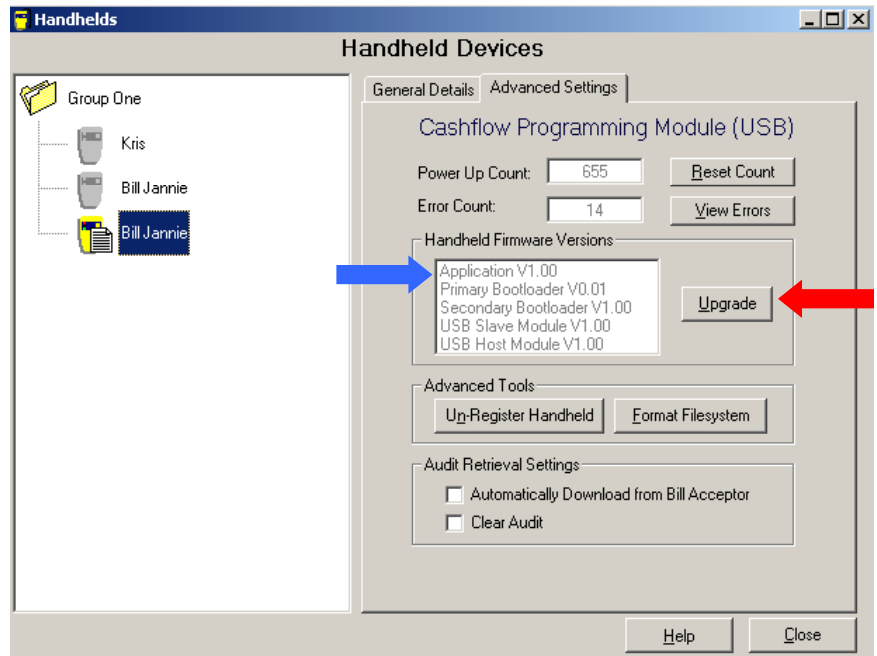
Fig.2

Note: If this prompt immediately disappears you can close out the Handheld Device window to view it again, or you can choose the Upgrade button located under the Advanced Settings tab on the Handheld screen (see Red arrow of fig.2)
