# Bill-to-Bill™ 300XE

currency management system

## Serviceability Manual

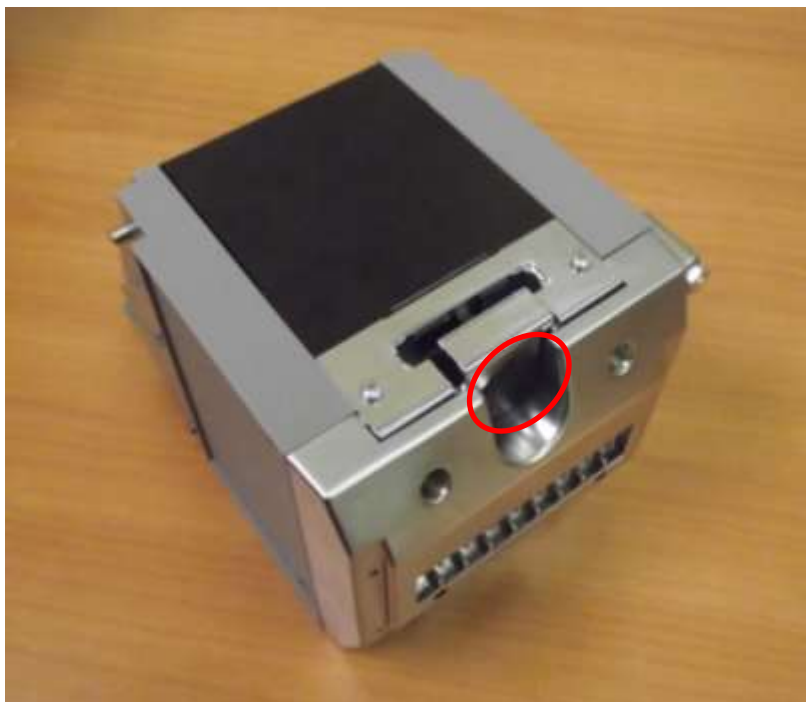
Additionally, special care should be taken when examining the cam lock mechanism on the dispenser. In many cases it may be bent or misshapen. This could compromise the security of the unit. Ensure that it is replaced as soon as any damage has been detected.
