MEI
Bill Acceptor
Series 2000
with MEI
FlashPort

Series 2000 Bill Programming Module (BPM)

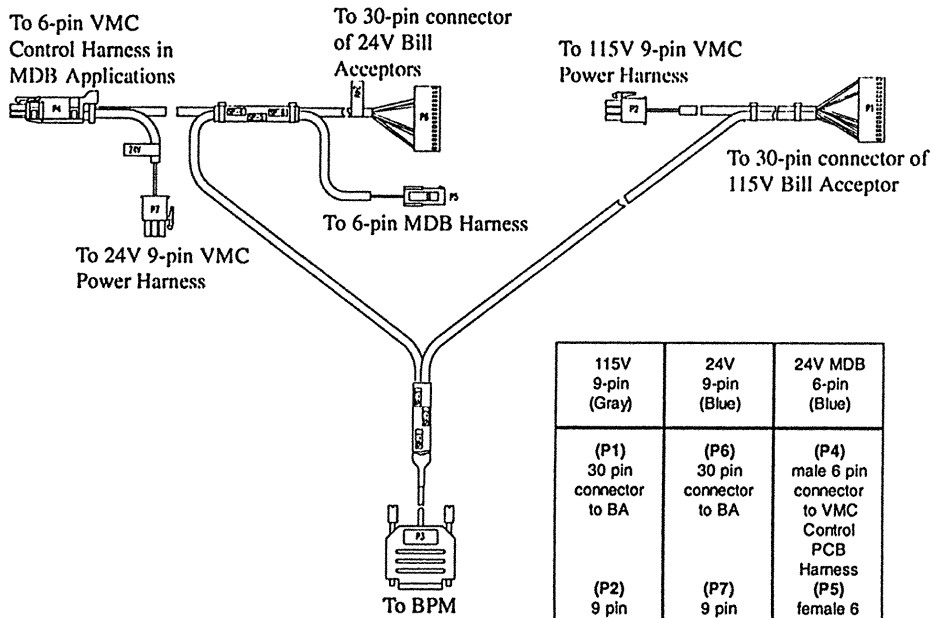
Connections:

115V 9-pin (Gray)	24V 9-pin (Blue)	24V MDB 6-pin (Blue)
(P1) 30 pin connector to BA	(P6) 30 pin connector to BA	(P4) male 6 pin connector to VMC Control PCB Harness (P5)
(P2) 9 pin connector to VMC Power Harness	(P7) 9 pin connector to VMC Power Harness	(P5) female 6 pin connector to MDB Harness

3. Connect the BPM (See next page), then power up the machine.
4. Once the bill acceptor completes a run and stack, (motors cycle) press the Red Button on the BPM till the Green LED illuminates to indicate power to the BPM.
